DESIGN AND CHARACTERIZATION OF STRAIN HARDENING CURAUÁ  
FIBER CEMENT-BASED COMPOSITES

Bartosz Żukowski

Tese de Doutorado apresentada ao Programa de Pós-graduação em Engenharia Civil, COPPE, da Universidade Federal do Rio de Janeiro, como parte dos requisitos necessários à obtenção do título de Doutor em Engenharia Civil.

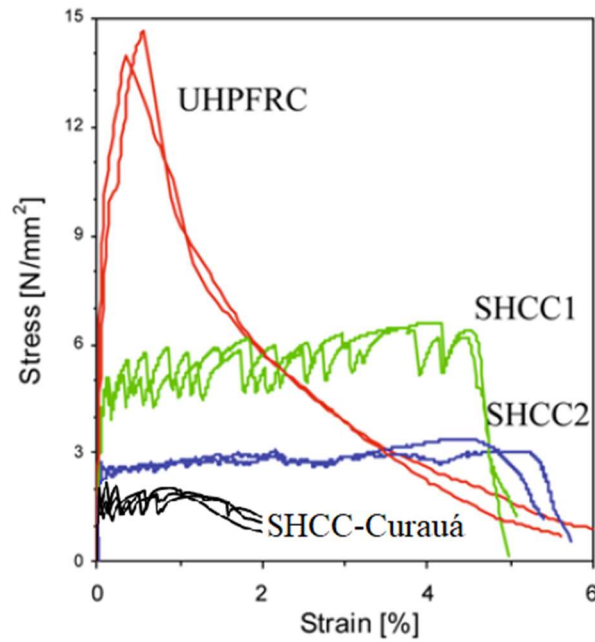
Figure 2-1 Uniaxial tensile behavior of classes HPFRCC compared to SHCC-curauá (40 mm fiber) adapted from (VAN ZIJL, 2009)

The strength and crack pattern formation in the SHCC differs from the Ultra-high performance fiber-reinforced concretes (UHPFRC), which present the high tensile and flexural strength with high compressive strength as well (180-240 MPa) but the cracks are localized in areas of weakness, where in SHCC they are distributed along the pseudo-plastic zones (VAN ZIJL, 2009). Figure 2-1 presents the classes of high-performance fiber-reinforced cement-based composites proposed by Van Zijl with the result of this research achieved for 4% of 40 mm curauá fiber.

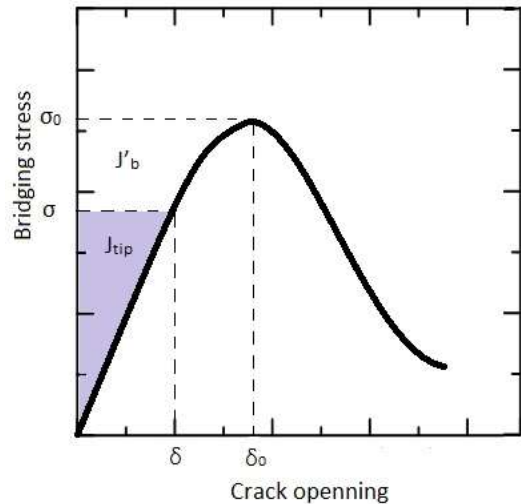
Figure 2-4 Crack tip opening curve with complementary energy ( $J_b$ ) and maximum bridging stress ( $\sigma_0$ ) for corresponding maximum crack opening ( $\delta_0$ ).

The concept of energy criterion is presented in Figure 2-4. It involves external energy (work) with crack tip energy absorption (matrix toughness) and cracks flank energy absorption (fiber-matrix bond). This energy criterion determines the crack propagation mode (steady-state or Griffith crack). The crack width ( $\delta$ ) should be below maximum crack opening that fibers can bridge ( $\delta_0$ ), to maintain the stress level below the bridging capacity of fibers (if stress will be above  $\delta_0$  tension softening with the crack opening will occur).

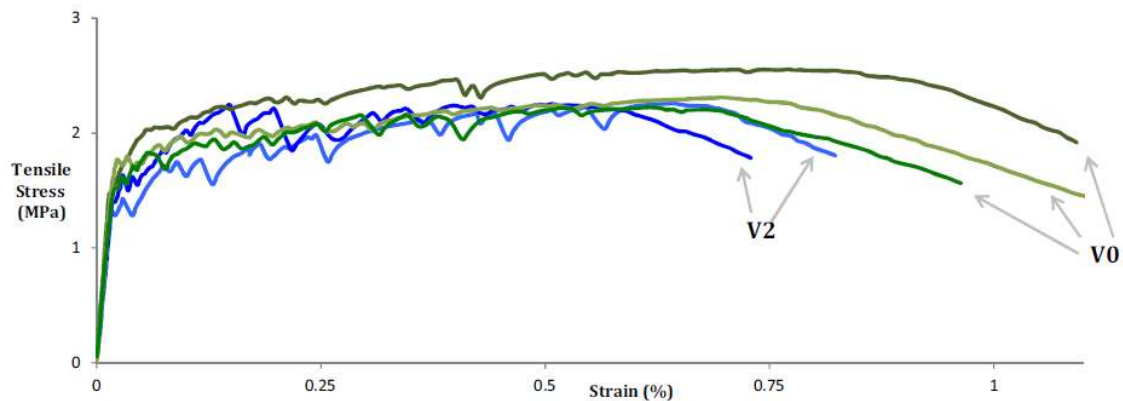
Figure 2-6 The influence of microsilica application in matrix on tensile strain capacity of SHCC with short curauá fiber and 1% of silane coupling agent, V0: no microsilica admixture, V2: 20% of microsilica admixture (SOLTAN et al., 2017).

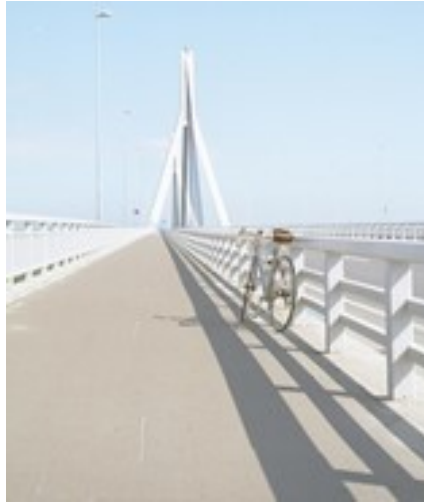
The Mihara Bridge in Ebetsu in Japan was constructed with SHCC layer (Figure 2-9). Intense traffic, heavy vehicles and fatigue damage was a reason to increase a thickness of reinforcement of steel floor deck with SHCC layer. The structure increased fatigue resistance due to stress reduction by a hybrid combination of steel deck and SHCC layer (MITAMURA et al., 2005).

*Figure 2-9 The Mihara Bridge (RISOMIRU, 2010).*

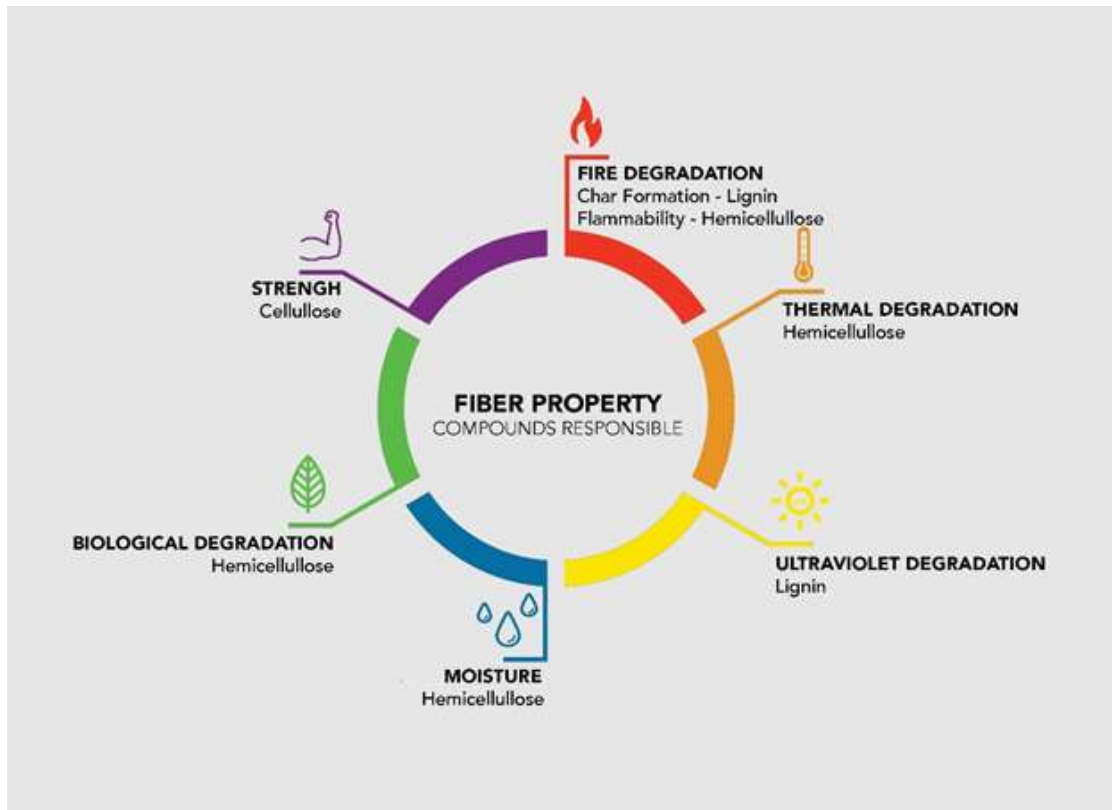
*Figure 2-12 Compounds responsible for natural fiber properties adapted from (AZWA et al., 2013).*

Application of natural fibers in cement composites is related to higher risk of fiber degradation in comparison to synthetic fibers. A comparison example of PVA fiber, which is considered chemically stable and presets high strength retention in acid solutions and organic solvents. The estimation based on tests carried by (HOSHIRO; NISHIYAMA; YAMAMOTO, 2006) which correlated tensile strength variation and UV absorption of PVA fibers immersed in hot alkaline water, shows the tensile strength retention of 100% in 60 years and 97.5% in 120 years. This opens an important chapter in PVA fiber substitution by natural fiber, which is durability. The natural fiber degradation depends on the environment condition. The Figure 2-12 presents the fiber's components susceptible to the environmental hazard.

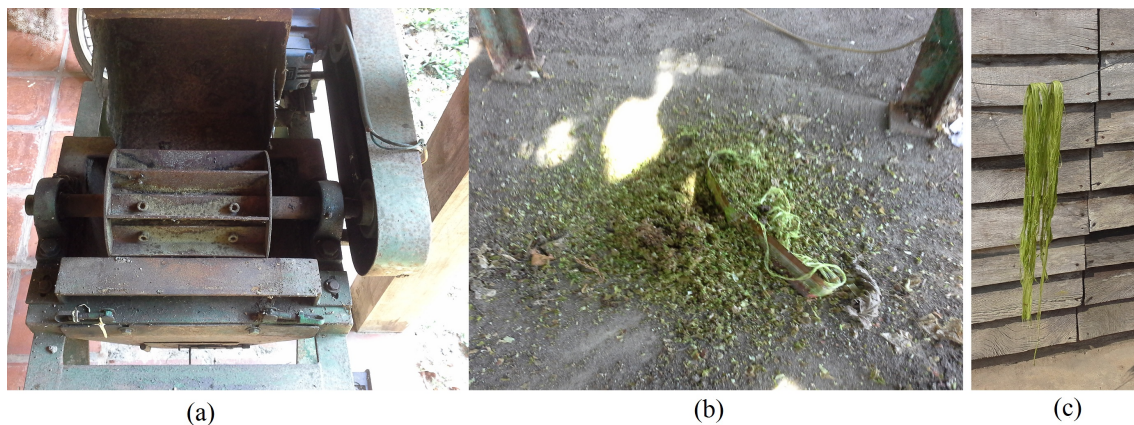
*Figure 2-18 Curauá fiber extraction, (a) machine used to fiber separation from leaves, (b) mucilage (residue after fiber extraction), (c) curauá fiber drying in the sun.*

Fibers are extracted by a mechanical process as illustrated in Figure 2-18. After extraction, the fibers are washed to remove residues and impurities. This residue is called mucilage (sap and fiber pieces) and is used as a nutrition component for animal or organic fertilizer after water dilution. Mucilage can be also used with fiber in recycled paper production (BRAGA et al., 2010). The washing process is important for fiber properties because residues can cause fungus growth on fibers and reduce their resistance. After washing, fibers are dried for 48 hours in natural conditions and then tied into bundles ready to distribution for future use.

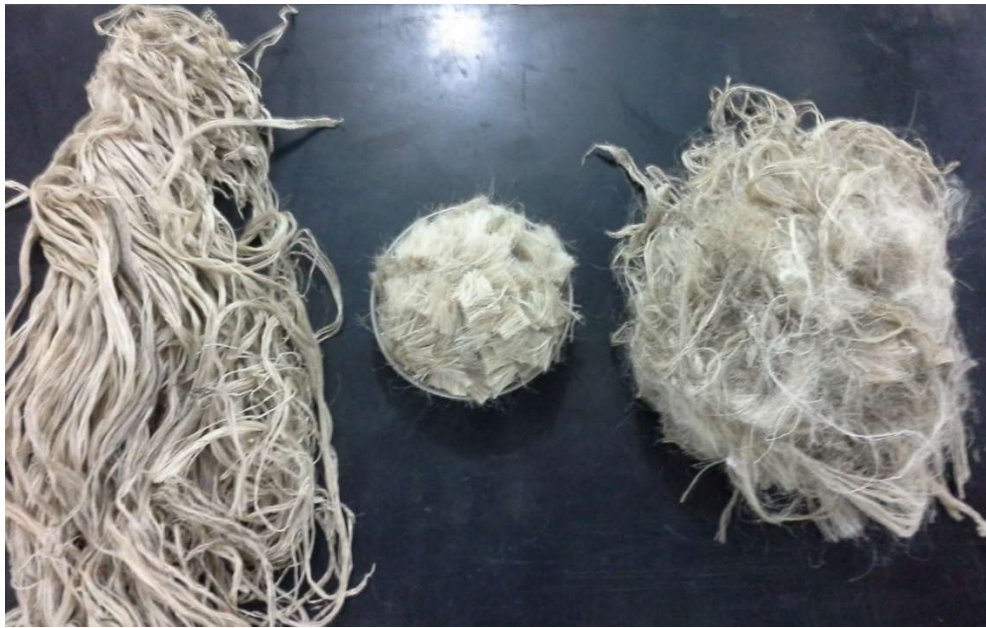
*Figure 3-2 The fiber preparation: fiber bundle (left), cut fiber (middle), residue (right).*

After washing cycles, the fiber is combed to separate single fibers from a bundle. The process was carried out manually at the timber board with nails used as a comb. All fibers tested for properties passed combing phase as a necessary condition for future implementation in composite and to prevent fiber agglomeration. There is no certainty about the influence of combing process on fiber properties. From one hand, it should separate the strong fibers from the weak ones (which stay at the comb). From the other hand, it introduced a tension on fiber bundle during combing, which could cause microdamage in fibers (which was not investigated in this study). The residue after combing can be used in gardening works in mat form, or shredded in pieces and mix with soil to improve aeration and water retention. For the price of 1-1.5 USD for 1 kg of fiber in a bundle (SOLTAN et al., 2017), there is 600 g of combed and chopped fiber ready to use in composite and 400 g of residue which can be reutilized. After combing the fiber was manually cut by scissors to desired lengths. The fiber before and after the combing and cutting is presented in Figure 3-2.

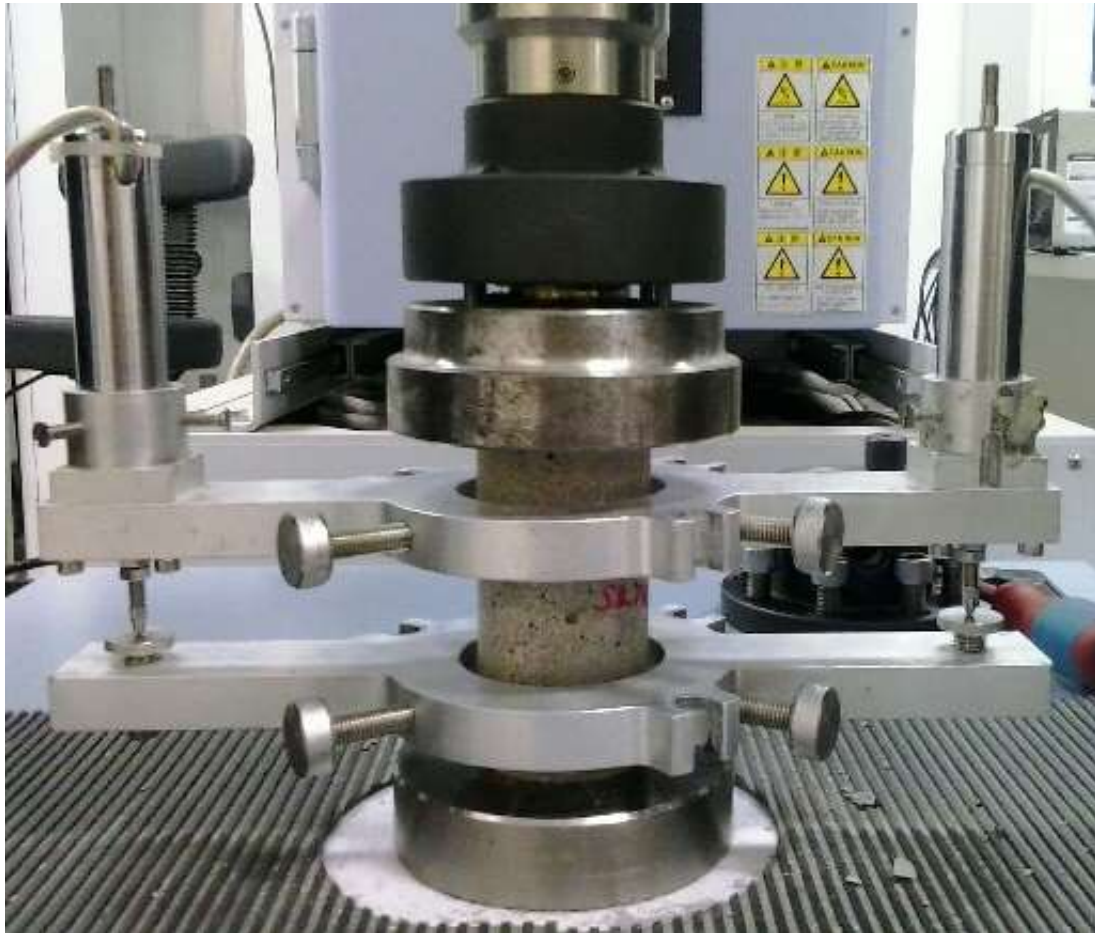
Figure 5-1 Compression test on cylinder specimen with deformation measured by LVDT.

Compressive strength was verified on cylindrical specimens (50x100 mm) at Shimadzu, with the load cell of 100 kN and 0.3 mm/min velocity (Figure 5-1).

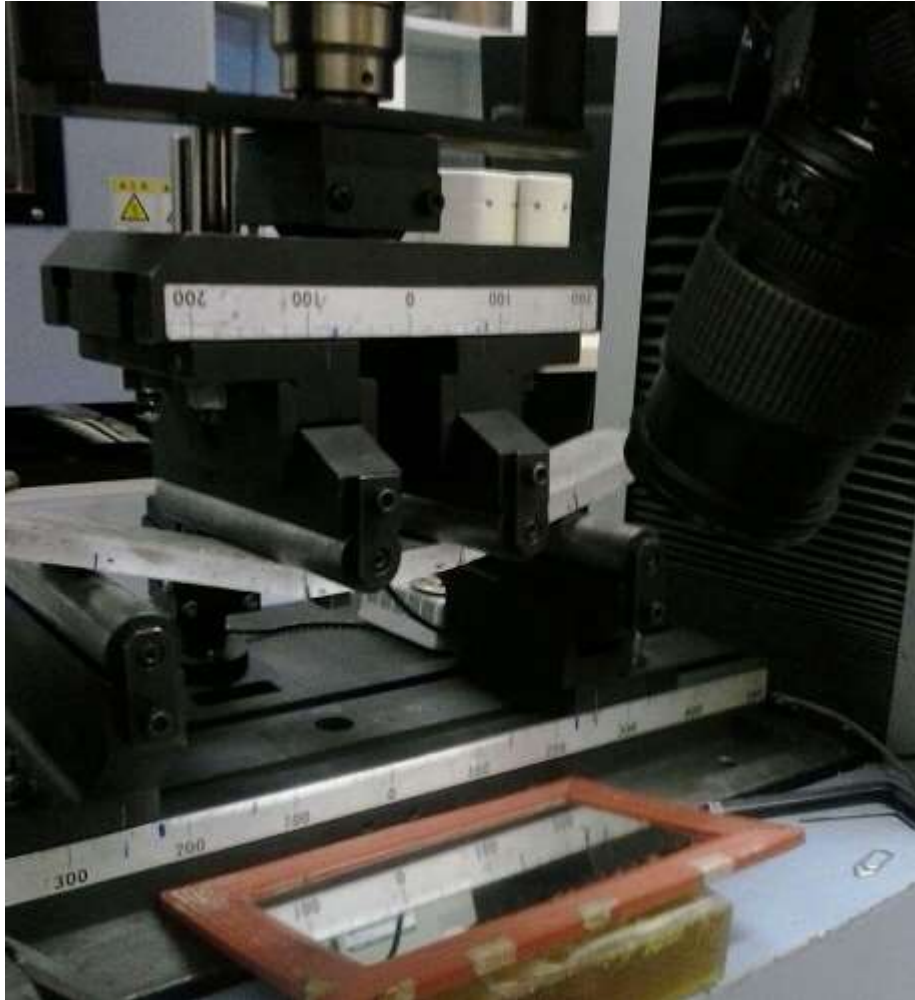
*Figure 5-9 The 4-point bending test with the middle span deformation span controlled by LVDT, camera image used for crack pattern analysis.*

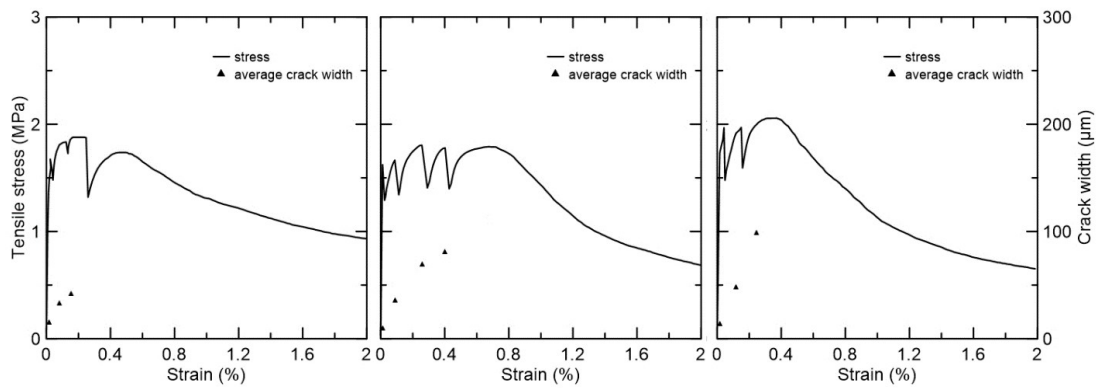
Figure 5-13 Results of tensile tests on dog bone specimens reinforced with 4% of 20mm two-stage treated curauá fiber.

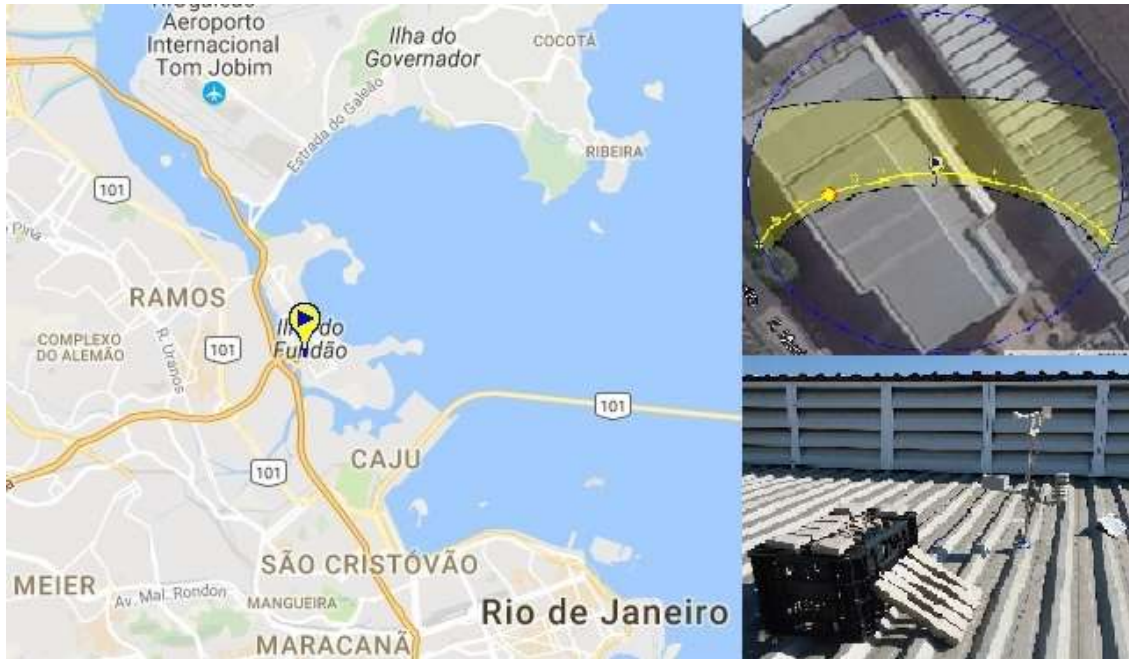
Figure 6-1 Location of natural weathering tests with sun path and specimens exposition on the roof (SunEarthTools.com).

Specimens were placed on the metallic roof, which is surrounded by a wall. The metallic surface could increase the temperature level of specimens that is why they were located on a plastic cage to provide good ventilation and reduce heat transfer from metallic roof to specimens. The Figure 6-1 presents the exact roof location with sun path on 24.01.2017 with underlined the shortest day (top black line) on 21<sup>st</sup> of June and the longest day (bottom black line) on 21<sup>st</sup> of December. The yellow filling represents the range of sun movement during the whole year period.

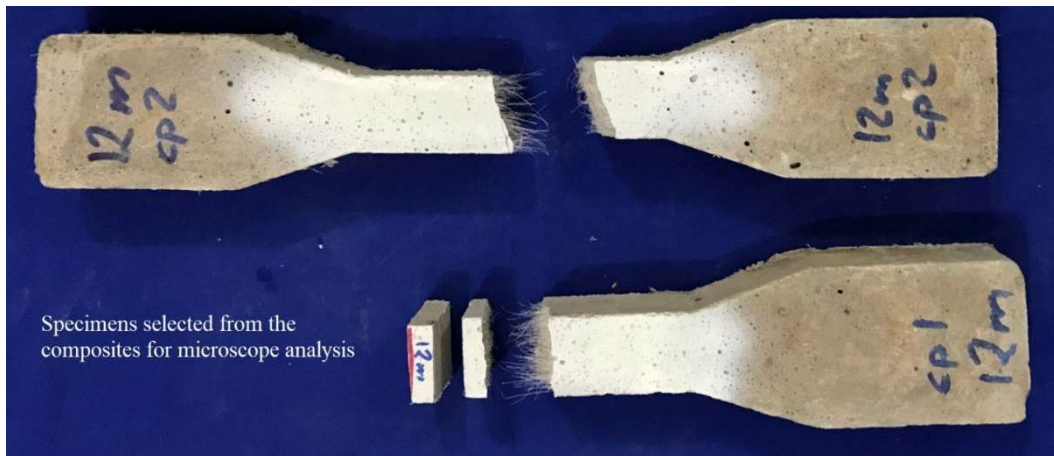
Figure 6-2 Preparation of the specimens for visual observation of fiber-matrix interaction.

The rectangular specimens were selected from the tensile region of dog bones and broken into halves to make visual observation of fiber-matrix interaction (Figure 6-2). The surface of the fractured specimens was observed under an optical microscope.

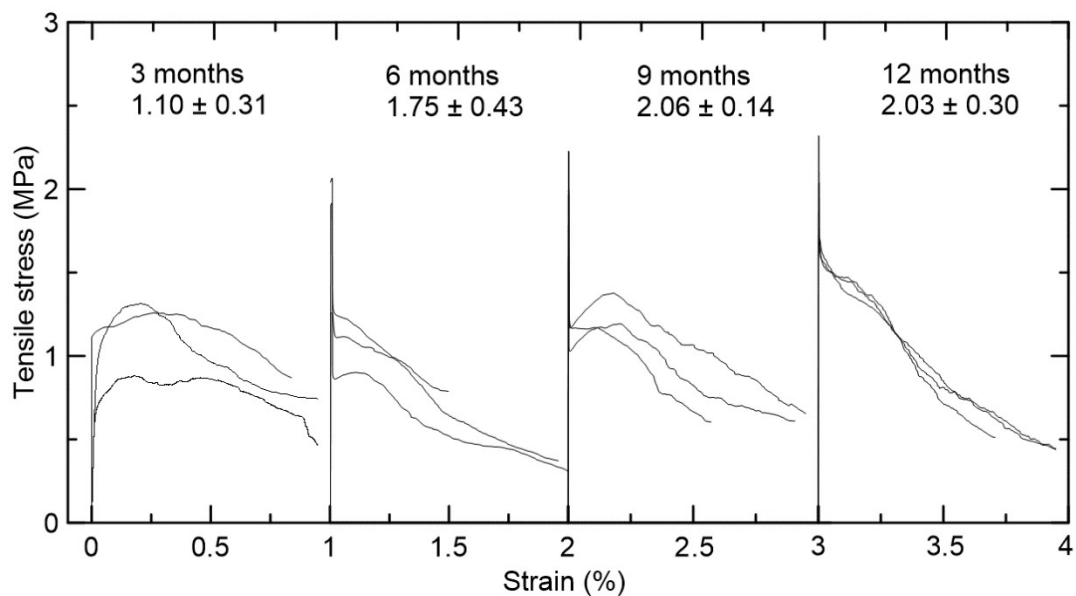
Figure 6-5 Results of tensile strength test carried on dog bone specimens exposed to 3, 6, 9 and 12 months of natural weathering.

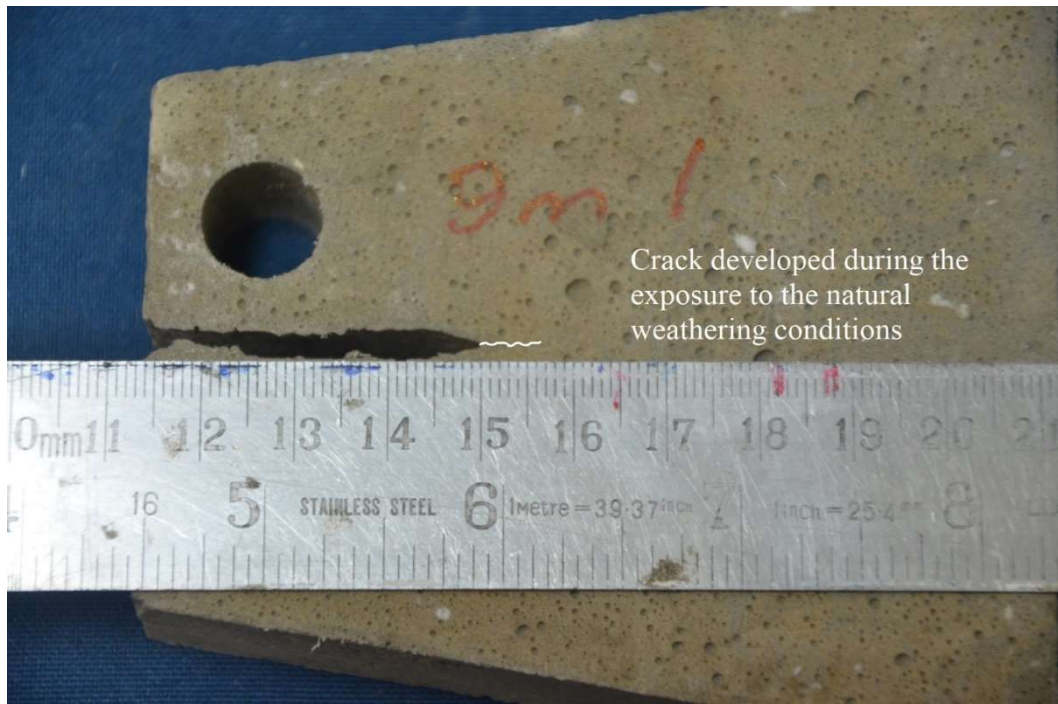
*Figure 6-8 Crack developed during the exposure to natural weathering conditions.*

Figure 6-8 presents the crack developed during the exposure to the natural weathering conditions at the specimen's notch. The cracks developed at the notch were in the range of 3-7 mm.

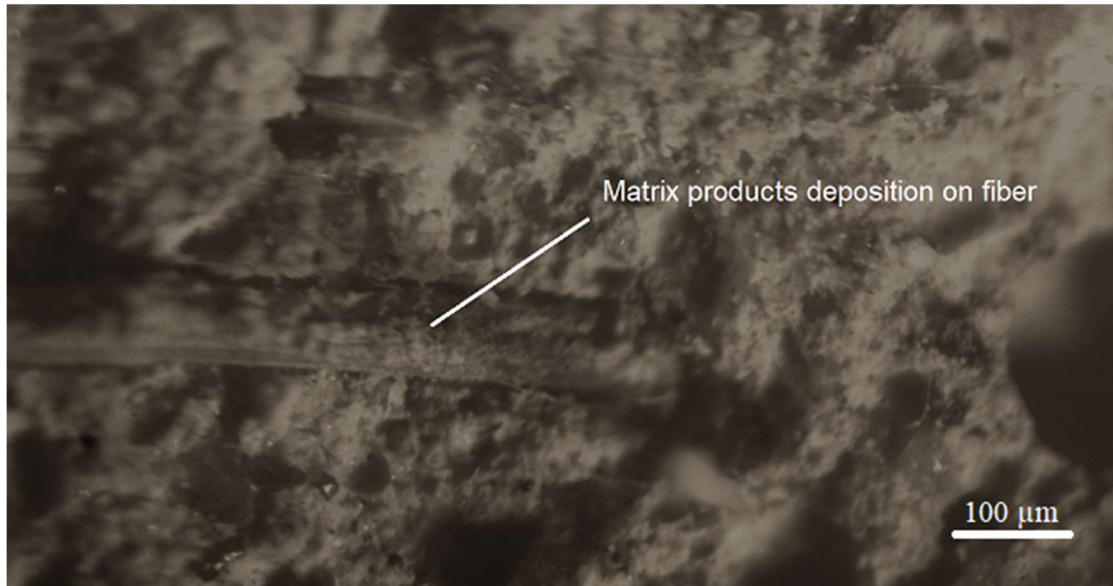
*Figure 6-17 Matrix products deposited on curauá fiber.*

Figure 6-17 presents the matrix products deposited on fiber's surface. This deposition indicates the good interaction between fiber's surface and the matrix, which is favorable for chemical bonding. The matrix products remained on fiber's surface after specimen fracture. This indicates the good interaction between fiber and matrix which is beneficial for bridging properties. However, the visible gap between the fiber and the matrix

indicates that after the exposure to natural weathering periods the connection has been reduced. The deposited matrix products can work beneficially increasing friction during the pull-out phase which could explain the maximum pull-out force ( $P_{max}$ ) higher in all cases than debonding force ( $P_d$ ).

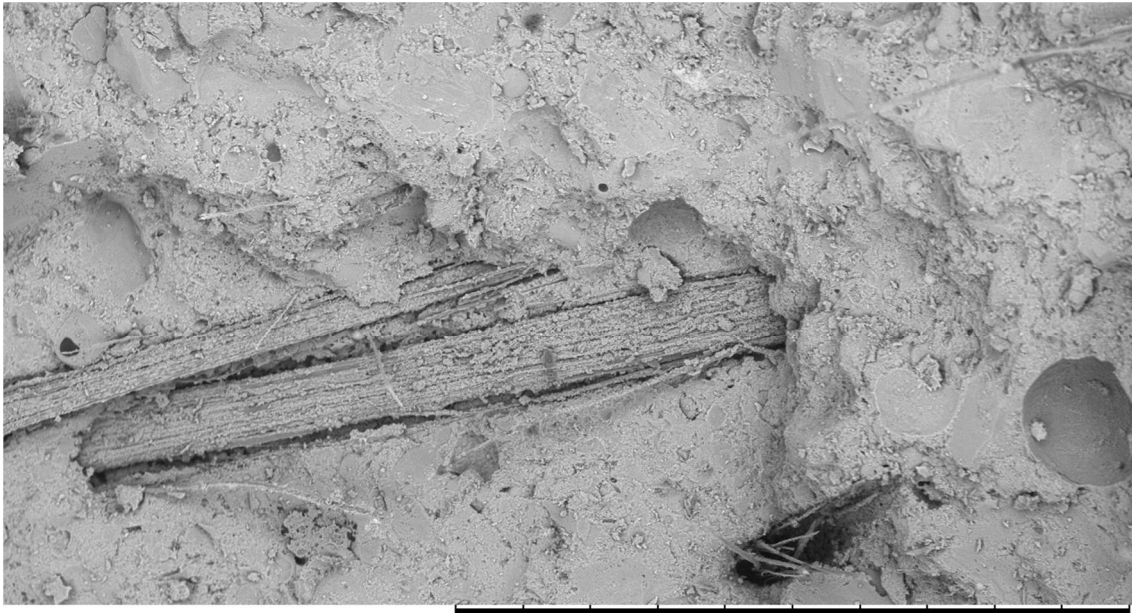
Specimen after 45 cycles

*Figure 7-6 Fiber-matrix gap in specimens submitted to 45 cycles of wetting and drying.*

Figure 7-6 presents the matrix products deposited on fiber's surface as well as fiber-matrix gap and defibrillation. The fiber-matrix gap reduces the contact area between fiber and matrix changing pull-out behavior to more frictional diminishing the influence of chemical bonding.
